ENGINEERING CASE LIBRARY

SOMETIMES IT GETS PUSHED

Fatigue testing of various axle shafts
SHAFTS WITH NON-CIRCULAR PROFILE

EVALUATION OF 5X591 AXLES WITH HEXAGONAL SHAPED
CONNECTIONS AT THE DRIVE ENDS IN DW15 TRACTORS
AT THE ARIZONA PROVING GROUND

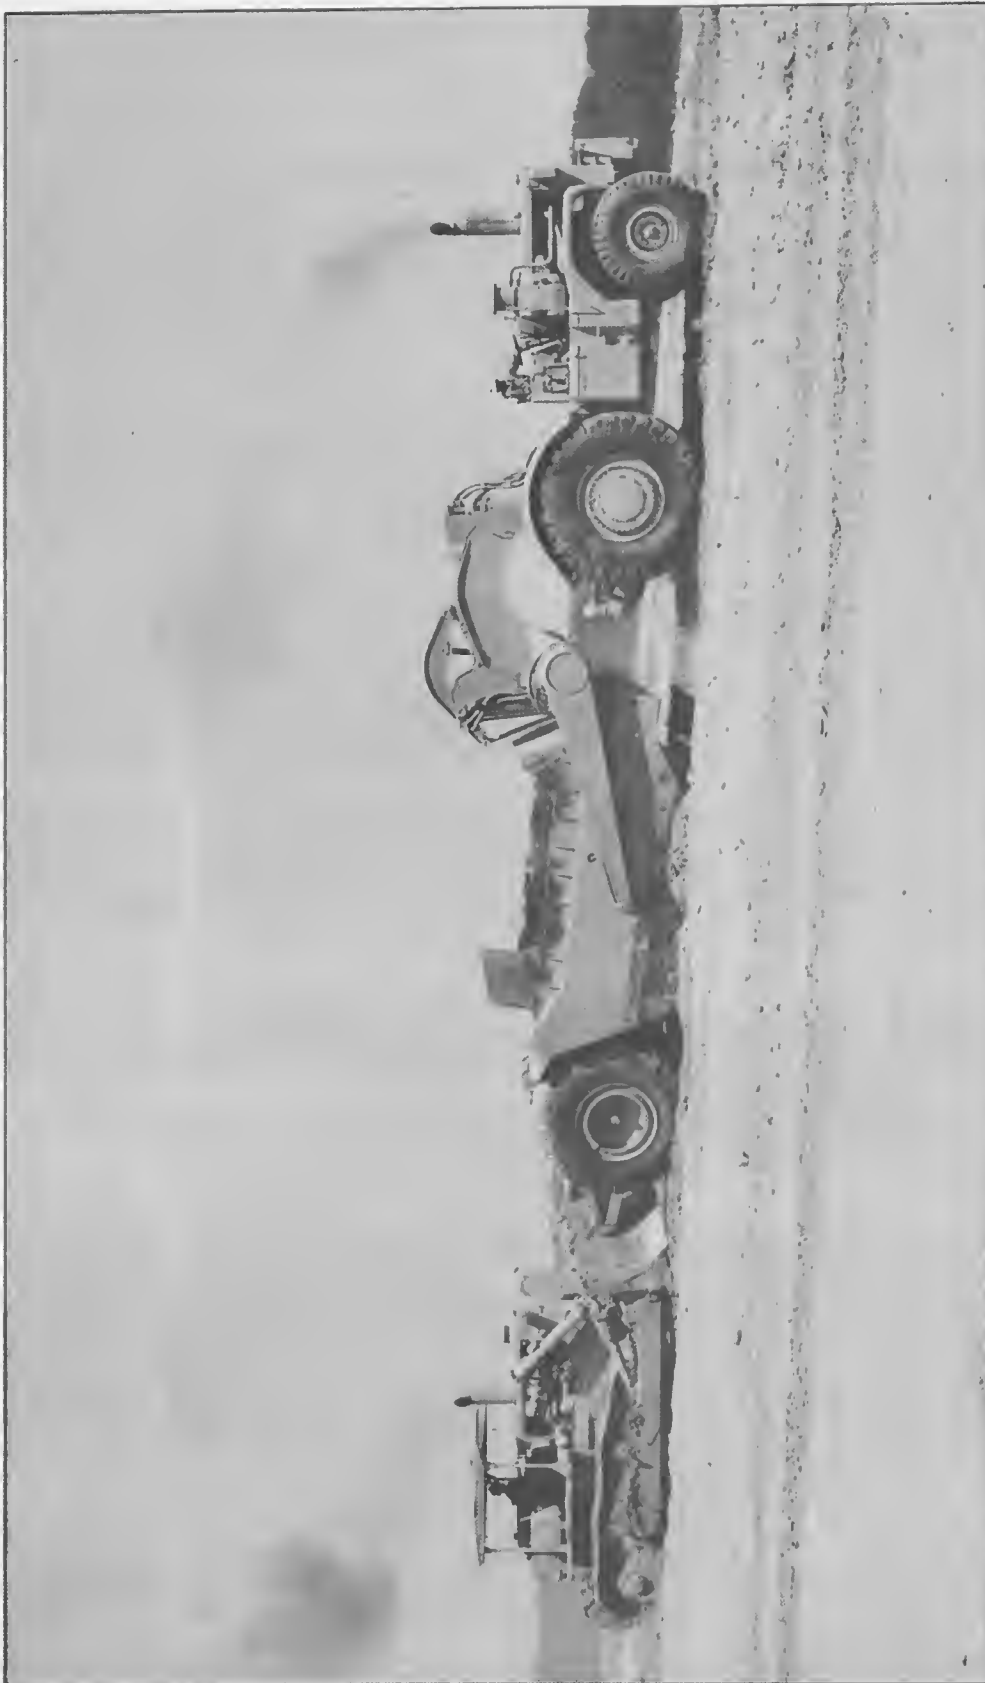
Figure 1

DW 15 Tractor With Bowl Scraper Being Assisted by a Push Tractor

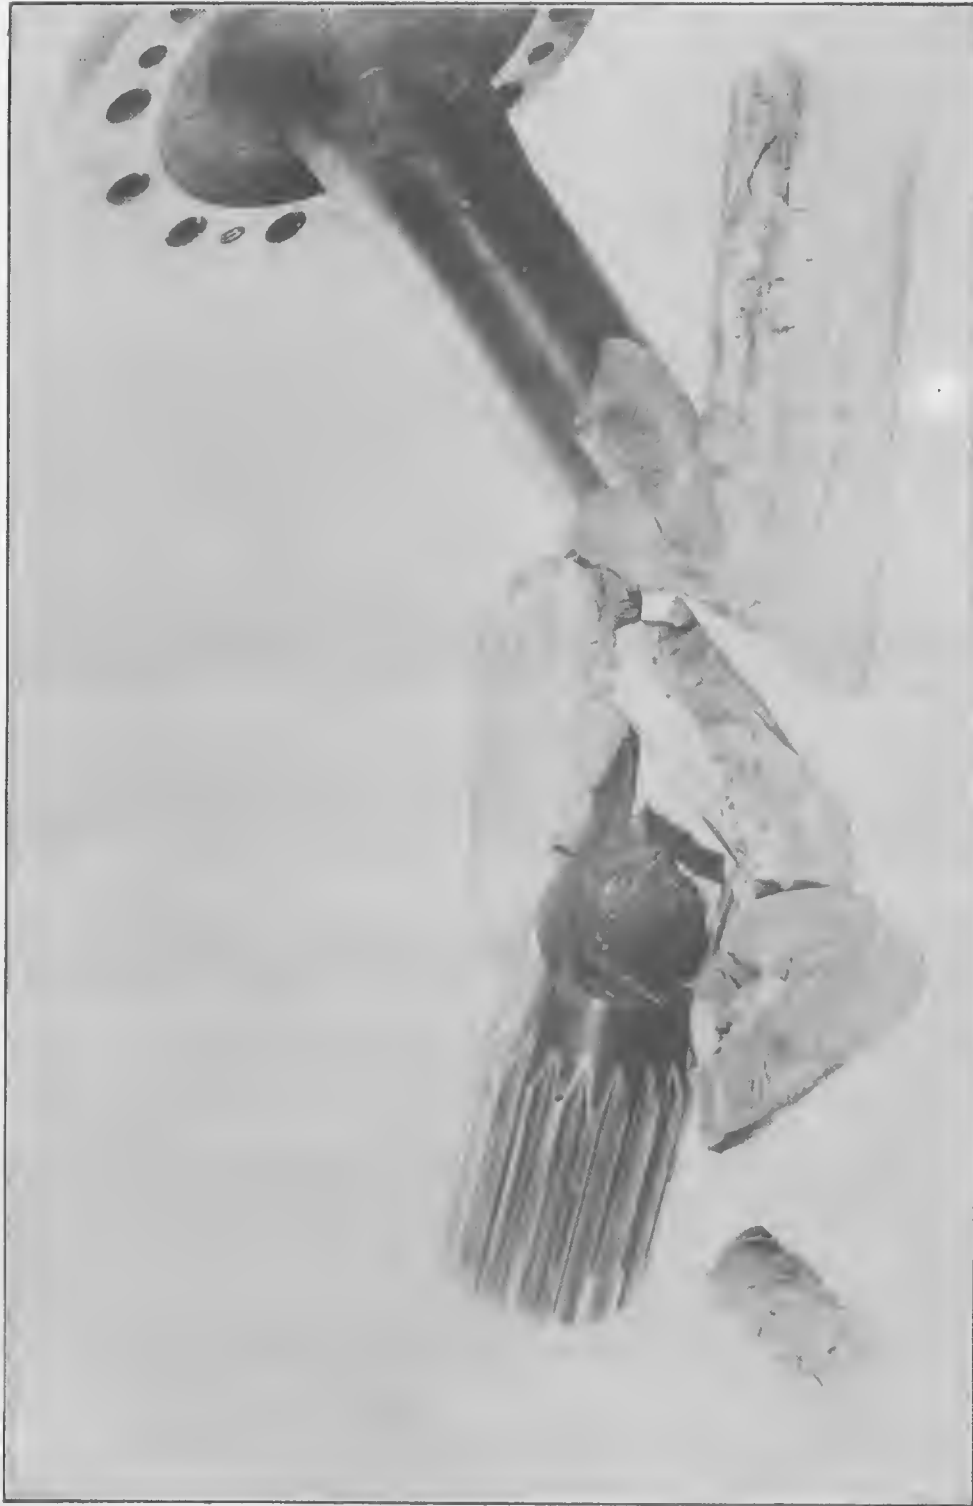
Figure 2

In the spring of 1954 Ed Eckert was handed a hot job. The Caterpillar DW 15 scraper type vehicle shown in Figure 1 had been on the market for about 6 months and already complaints about failed axle shafts had become too numerous. (Figure 2 shows a failed DW 15 axle shaft.) These complaints came from several customers, and in particular, from one customer in the area of Baltimore, Maryland.

A Failed DW 15 Axle Shaft

Once Ed and Marty arrived in Baltimore Ed mounted the instrumented axle shaft which they brought with them into one of the DW 15 tractors which was being used with a bowl scraper. The necessary recording equipment was bolted onto a piece of plywood and the plywood was attached to the fender of the tractor with C clamps. When Ed and Marty analyzed the data they could see what was happening. When the DW 15 needed some assistance from a push tractor, (see Figure 1), the torque in the axle shafts of the DW 15 was reversed. As the DW 15 was being pushed sometimes the wheels would slip. This reverse slipping of the DW 15's wheels caused its axles to experience a fully reversed torque. From the strain gage readings it was determined that this maximum reverse torque amounted to about 50,000 ft.-lbs.

In the original design it had been contemplated that the axles would need to be strong enough to take a forward "slip" torque in fatigue but not a fully reversed "slip" torque.

Ed started the torsional fatigue testing of axle shafts almost immediately after the machine was completed. As a result of the fatigue data obtained with the new torsional fatigue testing machine, a decision was made to strengthen the DW 15 axle shafts by changing the material from 8645 steel to 86B45 steel. This new material was very similar to the original except for a small amount of added boron. The boron was added to increase the hardenability of the steel. The spline design was also changed to provide a full radius at the root of each spline. (See revision notes shown on the shop drawing in Figure 2.) Finally the shafts were severely shot-peened to increase their fatigue strength to the desired amount.

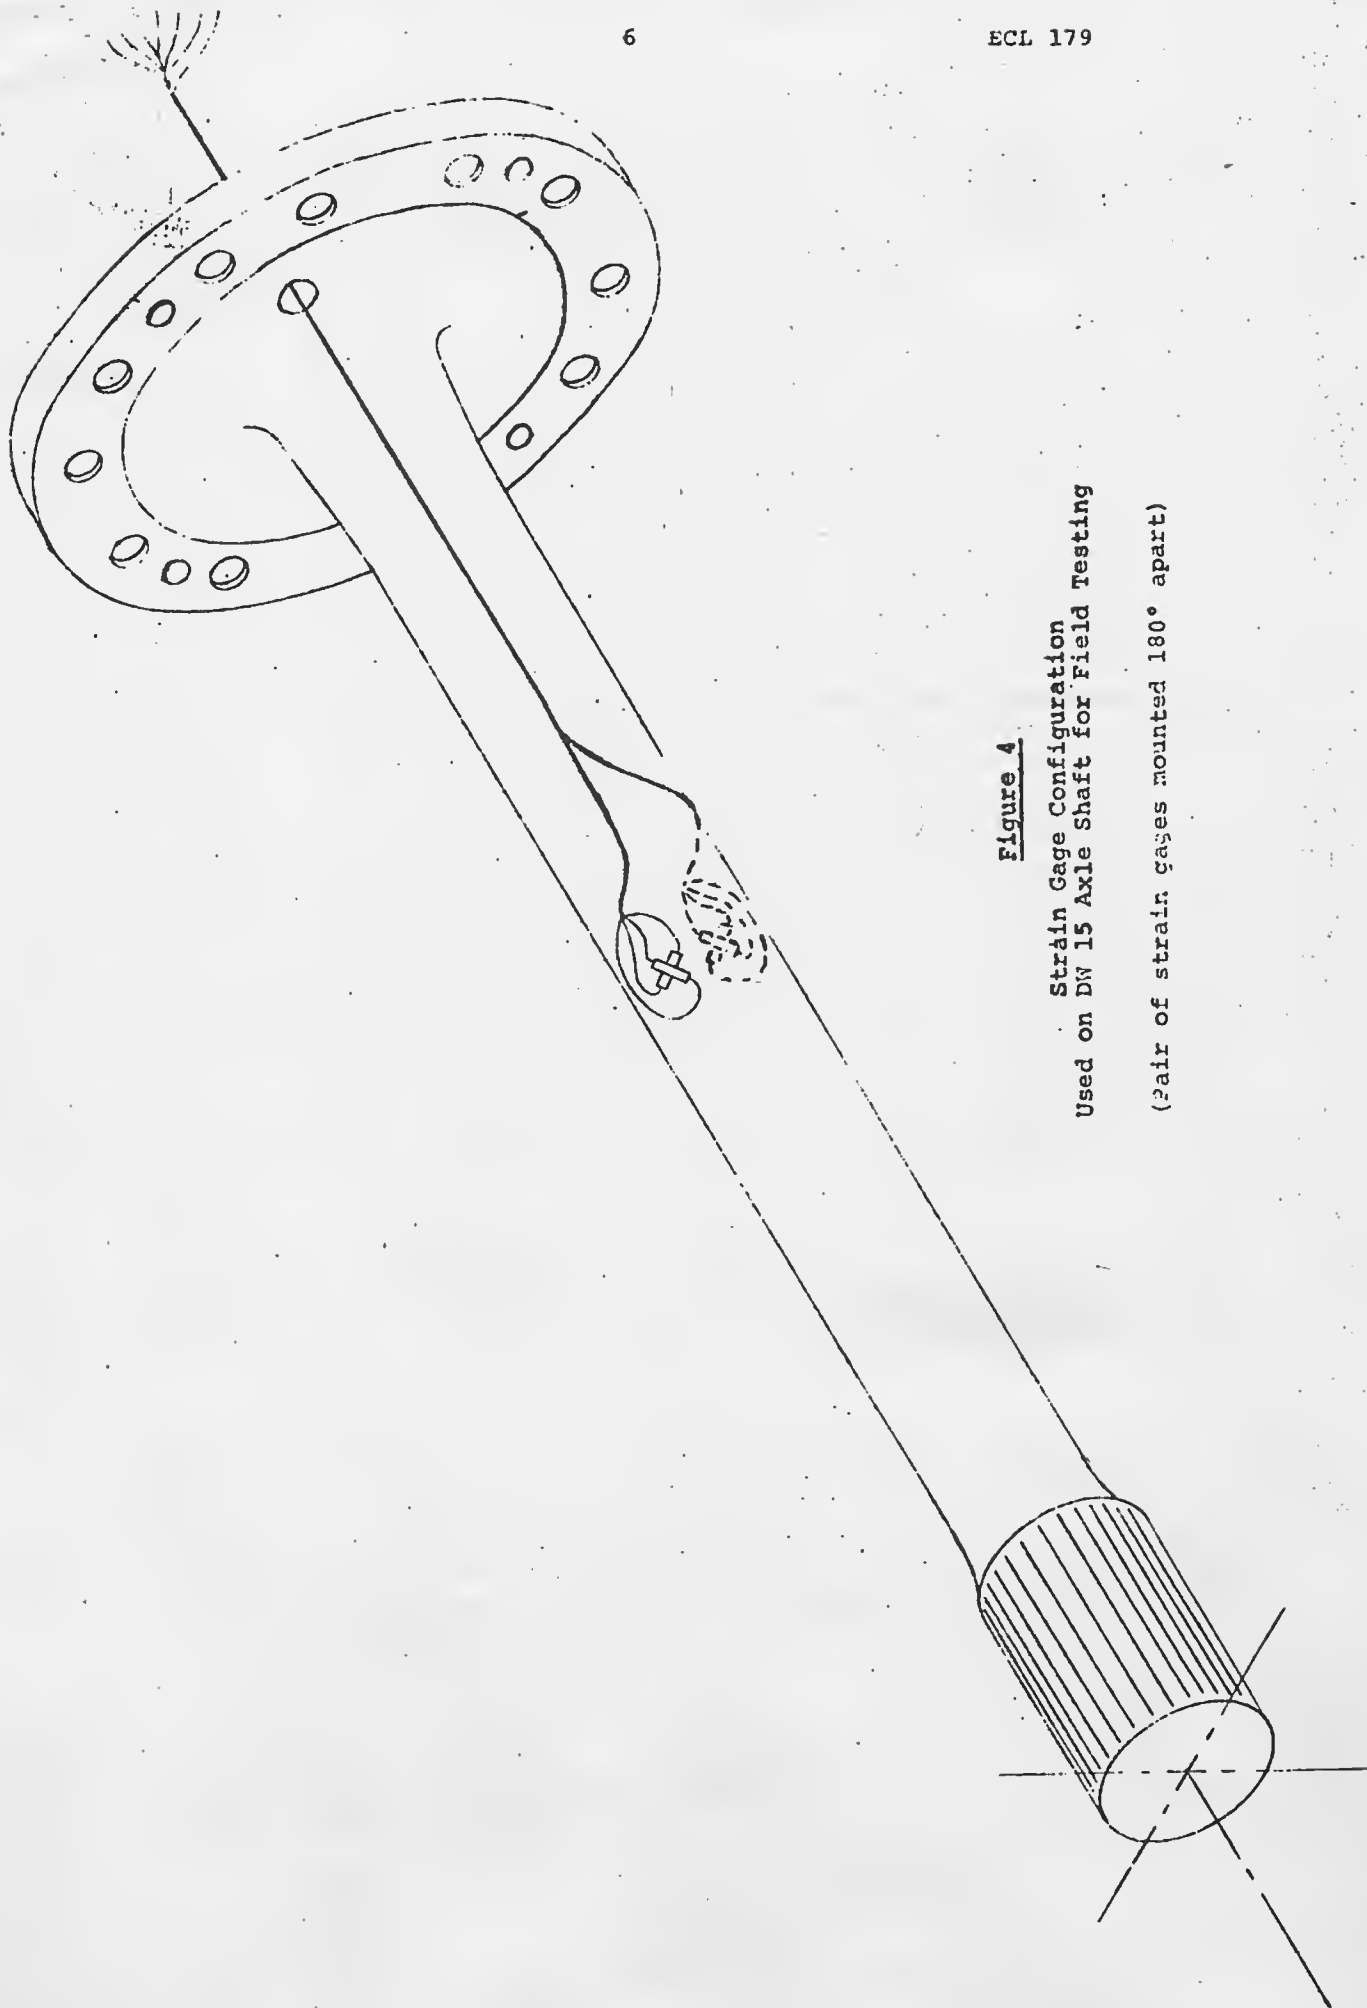
Figure 4

Strain Gage Configuration
Used on DW 15 Axle Shaft for Field Testing
(pair of strain gages mounted 180° apart)

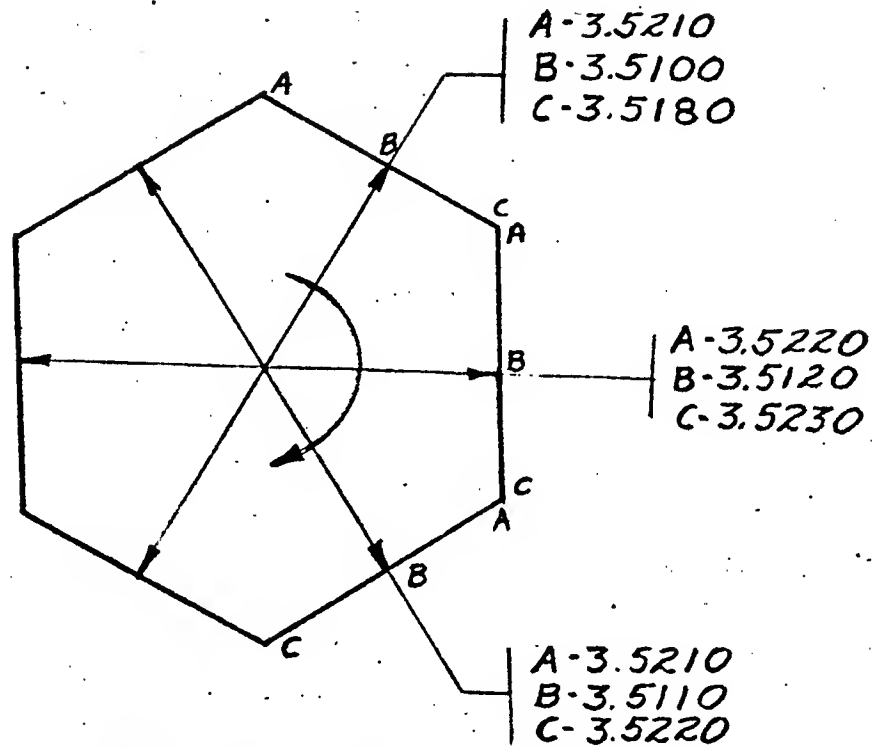
The right 5X591 axle and 5X992 final drive gear in 1A1425 were removed from test after 1677 hours (smr 4010). These parts were operating satisfactorily before they were removed but when removed there was evidence of seizure between the 5X591 axle and the 3H9165 tube housing at about the middle of the shaft as shown on Sheet B, (Photograph No. 6593). The hub and axle showed considerable wear and fretting on the hexagonal mating parts. This shaft was returned to Peoria.

WEAR ON 5X592 HUB FROM 1A1425
AFTER 1677 HOURS

1. Decrease the clearance between the 5X592 bull gear hub and the 5X591 axle to help reduce line contact for further testing.
2. Increase the hardness of the hub in 5X592 final drive gear.

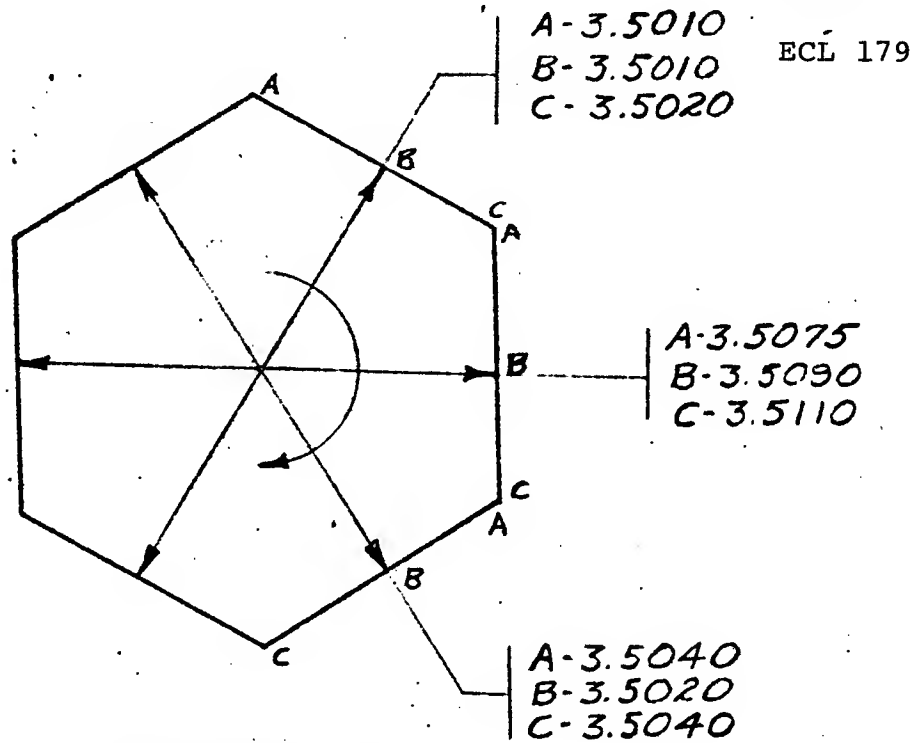
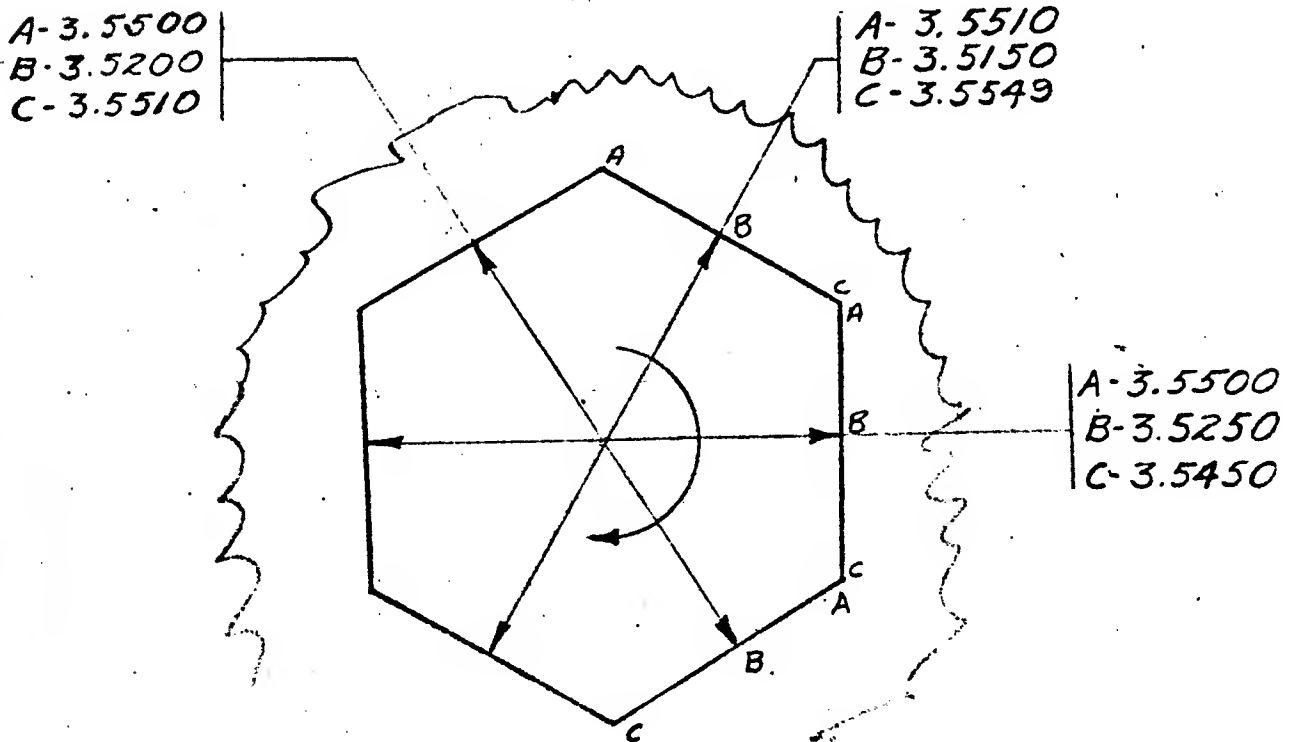
SHEET - E
FILE 13345-11
5-17-57

One tooth in the left 5X592 final drive gear failed after 2187 hours in 1A1425. The mating areas of the axle and final drive gear hub were worn and fretted as shown on Sheet C. This shaft and hub were measured (see Sheet E). From these measurements, it can be seen that the wear in hub is greater than on the axle. The increase in the section across the flats at the corners on the axle indicates that there may be metal transfer from the hub to the axle. It is possible that this wear allowed enough backlash in final drive to shock load the gear train which resulted in the final drive gear tooth failure.

When these parts are installed new there is only line contact between the hub and axle. This does not give sufficient bearing area and the mating surfaces start to yield. This is further aggravated by relative movement between the two parts. This situation would be relieved if the clearance between the hub and axle were reduced to a very light press fit and the hardness of the hub increased. This light press fit could result in a serious disassembly problem, especially if the serious fretting continues. It is therefore recommended that new axles be made up for test with a light press fit between the mating hub and axle. Provisions should also be made to pull the axle when disassembly is necessary. Special attention

WEAR ON AXLE AND FINAL DRIVE GEAR
HUB AFTER 2187 HOURS
